CHANCEL
Ground Floor Plan 1:50

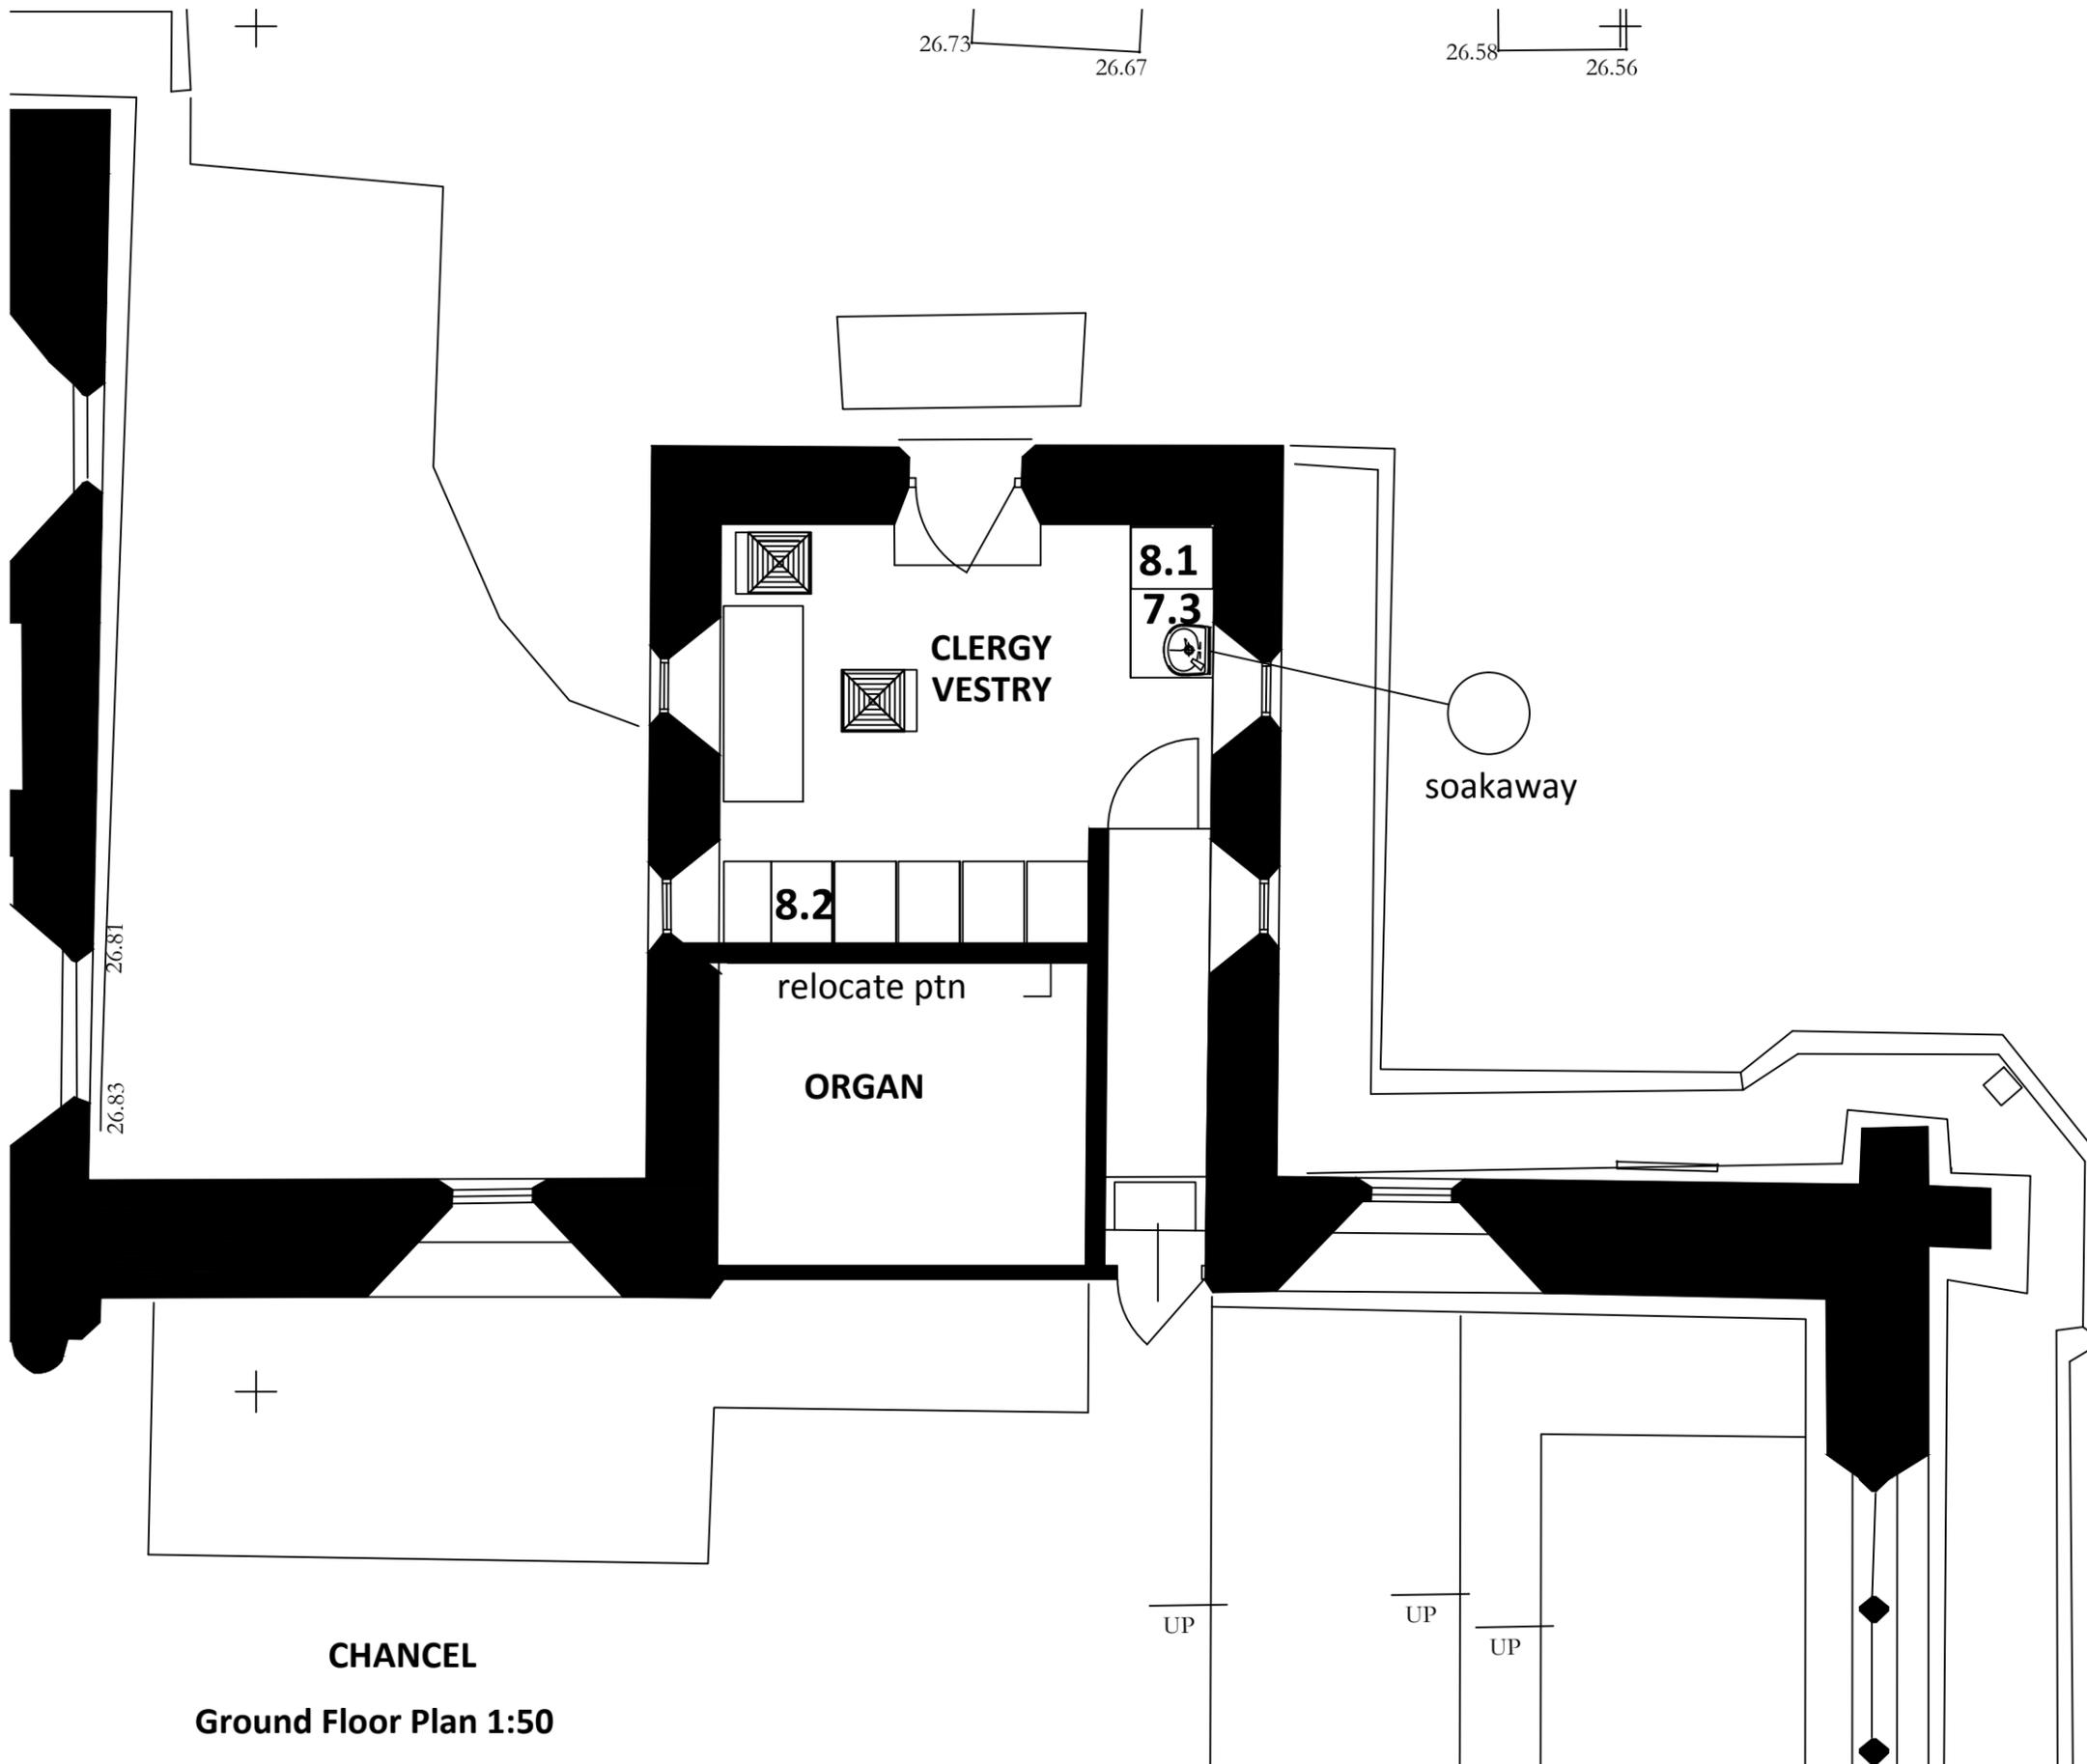
Remove south studwork partition between Vestry and Organ housing.

Form supporting structure for Safe

Form underfloor heating in trays between joists. Insulation below. Ensure min 50mm ventilation below insulation.

Reinstate ex boards on 9mm ply sheeting. Alternative option to form new floor of engineered hard wood.

Form new 100 timber stud partition 2.1 h in new location to in line with south reveal of southern most window to west Vestry elevation, approx 700mm into the ex Organ housing. Board out reveals and soffit and finish with plasterboard and skim coat.

Form Blind Panel to lower window within reveal. Reglaze with leaded lights clear cast glass.

7.3 Wash Basin: Fit new wash basin, water heater, cold supply to discharge into soakaway to west of Vestry.

8.1 Relocate Safe from former Choir Vestry

8.2 New cupboard/Vestments cabinet in painted Tulip wood to new recess
